Calleguas Creek Watershed Draft Fact Sheets
2002 303(d) List of Impaired Waterbodies

**Calleguas Creek Watershed
Sedimentation**

**Calleguas Creek Watershed – Conejo Creek/Reach 9B
Unnatural Foam & Scum**

**Calleguas Creek South – Reach 2
Water Column Toxicity**

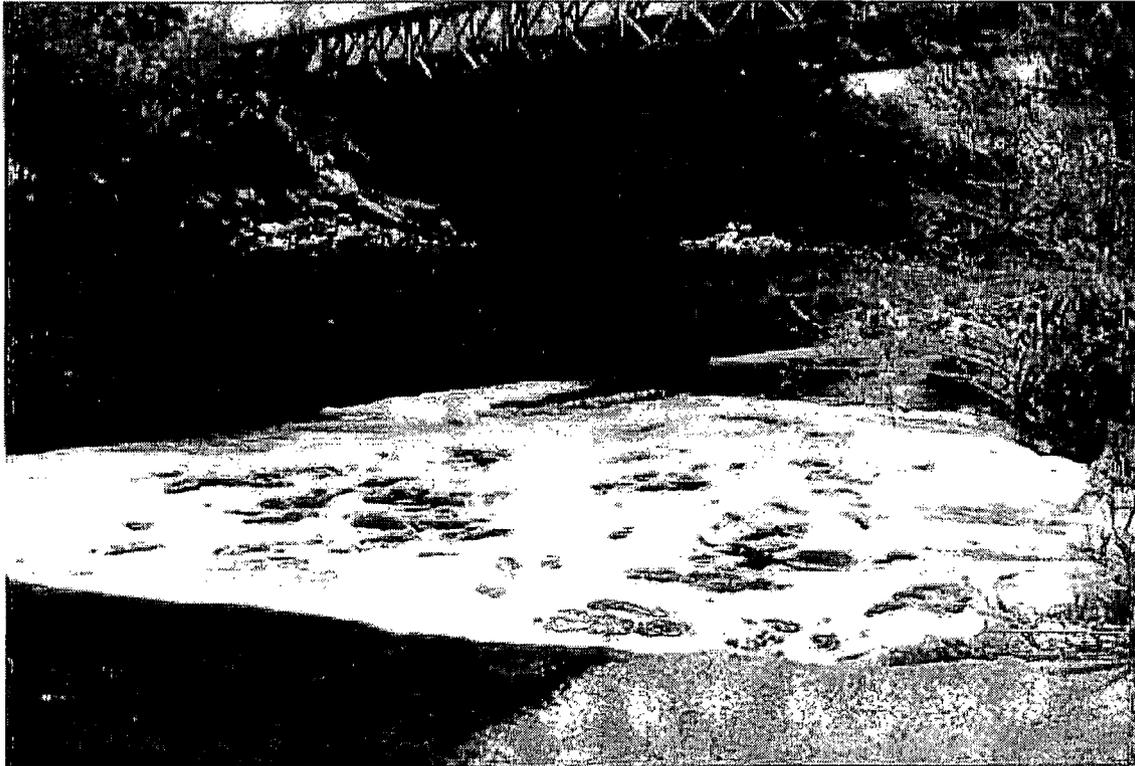
Photographic evidence of gross impairment of water quality due to unnatural foam and scum was provided for several dates in February and April of 2001 at locations downstream of the Hill Canyon Wastewater Treatment Plant.

Figure 1:
Sample of Photographic Documentation of Gross Impairment due to Unnatural Foam and Scum in Reach 9B
(Photo taken on 4/21/01)

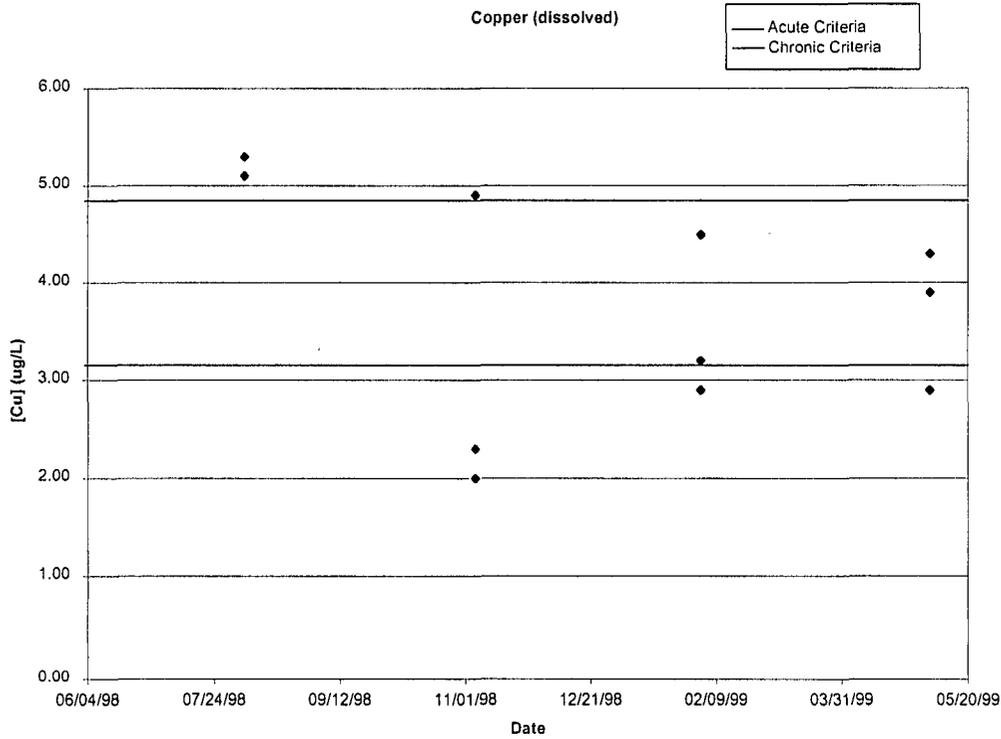
Table 2. Summary of Copper Data for Calleguas Creek Reach 2

Dates of Sampling	8/98-5/99
Number of Samples (n)	11
Minimum Data Value	2.0 ug/L
Maximum Data Value	5.3 ug/L
Median Data Value	3.9 ug/L
Arithmetic Mean Value	3.75 ug/L
Standard Deviation	1.16 ug/L
Number (Percent) above Objective	7 (64%) for 4 day; 3 (27%) for 1 hour salt water standard

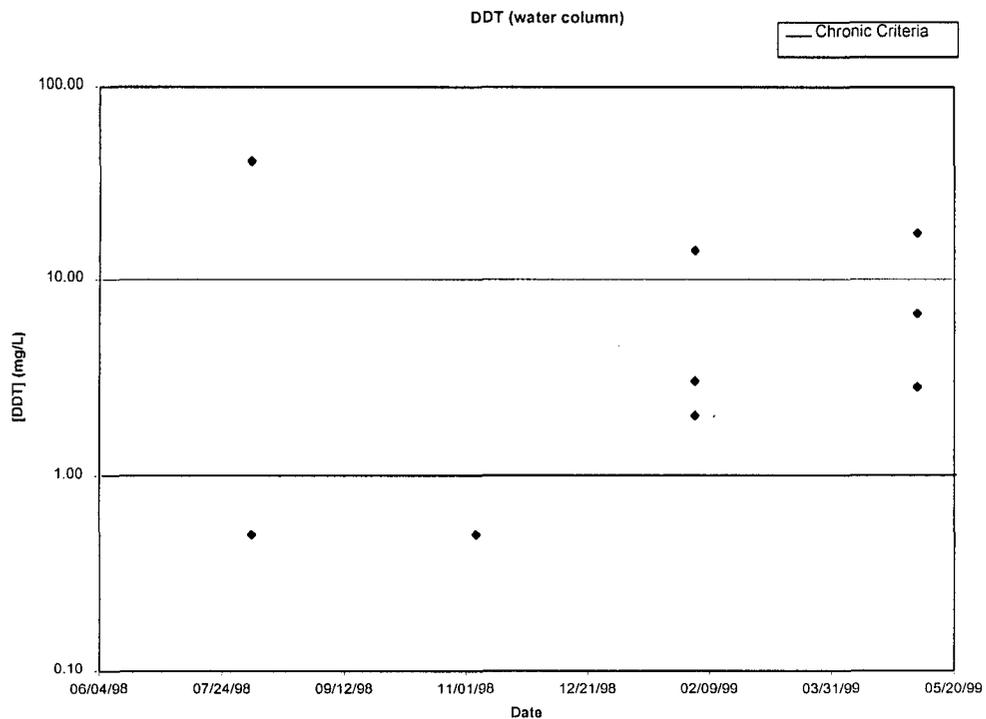
Data Assessment**Table 2. Summary of DDT in the Water Column Data for Calleguas Creek Reach 2**

Dates of Sampling	8/98-5/99
Number of Samples (n)	11
Minimum Data Value	<0.50 ng/L
Maximum Data Value	40.3 ng/L
Median Data Value	2.8 ng/L
Arithmetic Mean Value	8.0 ng/L
Standard Deviation	12.6 ng/L
Number (Percent) above Objective	7 (64%) exceed standard of 1 ng/L.

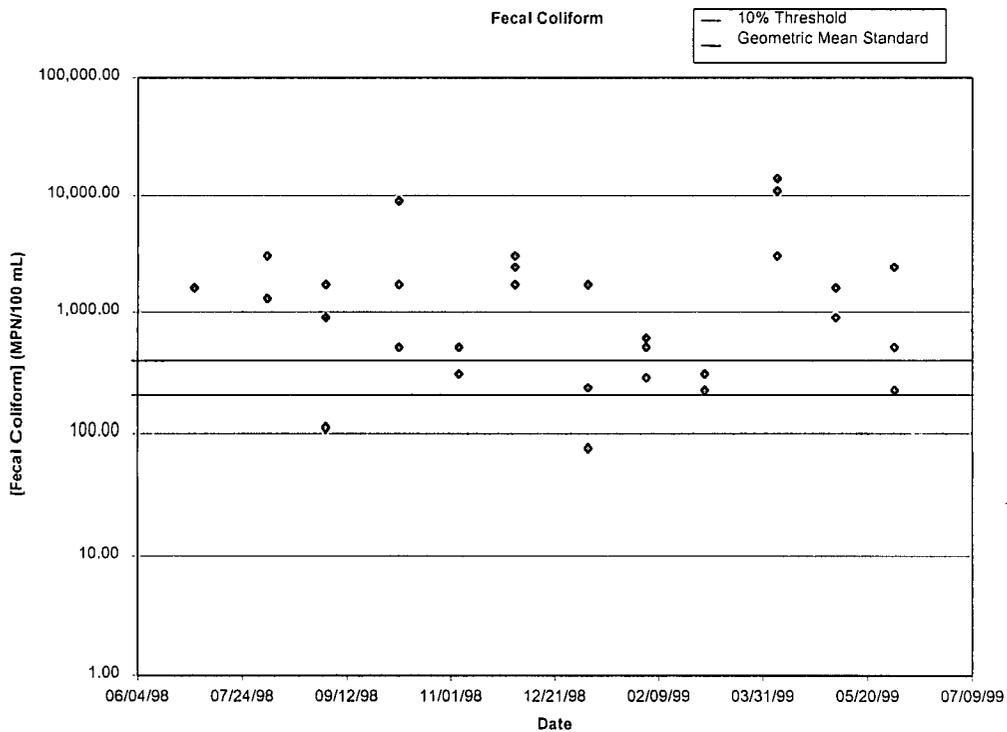
Table 2. Summary of Fecal Coliform Data for Calleguas Creek Reach 2

Dates of Sampling	7/98-6/99
Number of Samples (n)	34
Minimum Data Value	80 mpn/100mL
Maximum Data Value	14000 mpn/100mL
Median Data Value	900 mpn/100mL
Arithmetic Mean Value	2016 mpn/100mL
Standard Deviation	3133 mpn/100mL
Number (Percent) above Objective	Geomean of 934 exceeds 200 mpn standard; 24 (74%) >400 mpn.

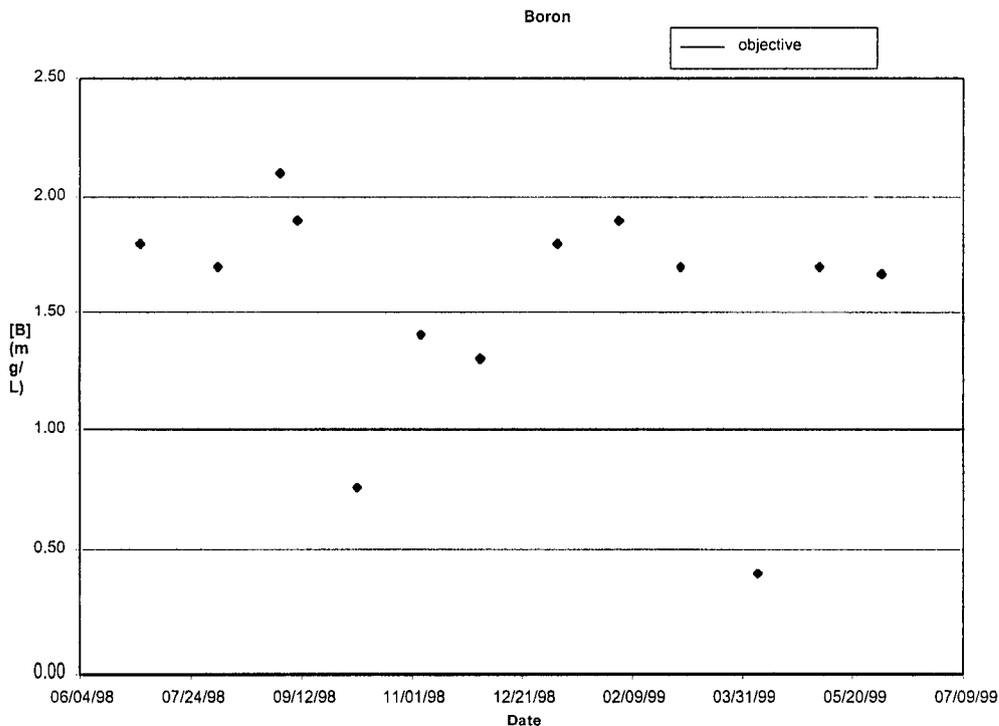
Table 2. Summary of Boron for Calleguas Creek Reach 4

Dates of Sampling	7/98-6/99
Number of Samples (n)	13
Minimum Data Value	0.40 mg/L
Maximum Data Value	2.10 mg/L
Median Data Value	1.70 mg/L
Arithmetic Mean Value	1.49 mg/L
Standard Deviation	0.48 mg/L
Number (Percent) above Objective	11 of 13 or 85%

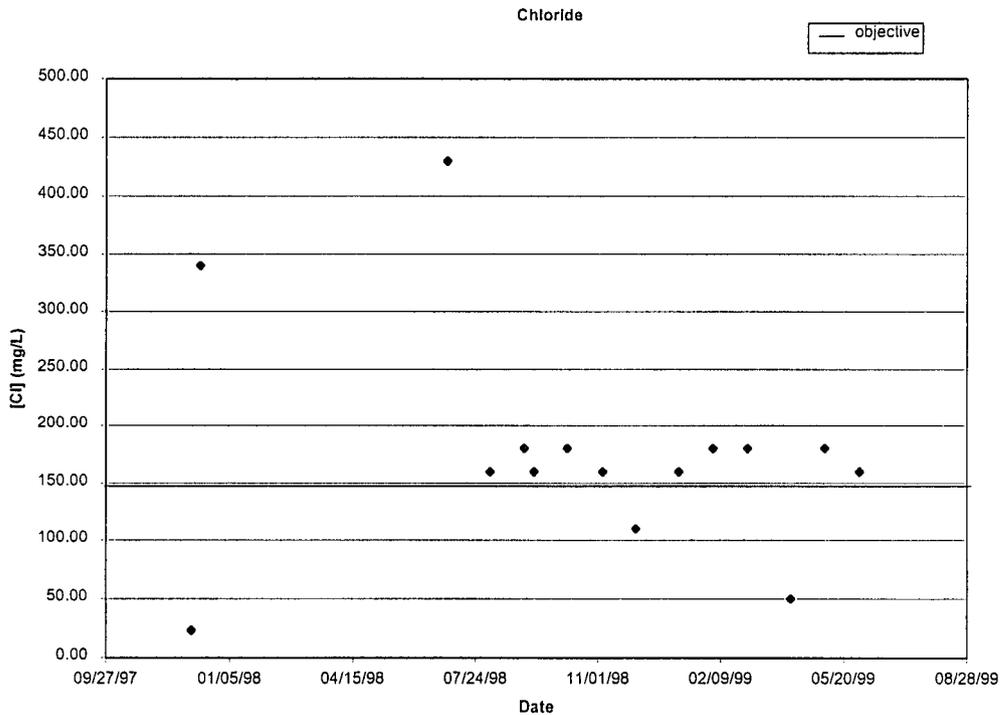
Table 2. Summary of Chloride for Calleguas Creek Reach 4

Dates of Sampling	12/97-6/99
Number of Samples (n)	15
Minimum Data Value	23 mg/L
Maximum Data Value	430 mg/L
Median Data Value	160 mg/L
Arithmetic Mean Value	177 mg/L
Standard Deviation	99 mg/L
Number (Percent) above Objective	12 or 80%

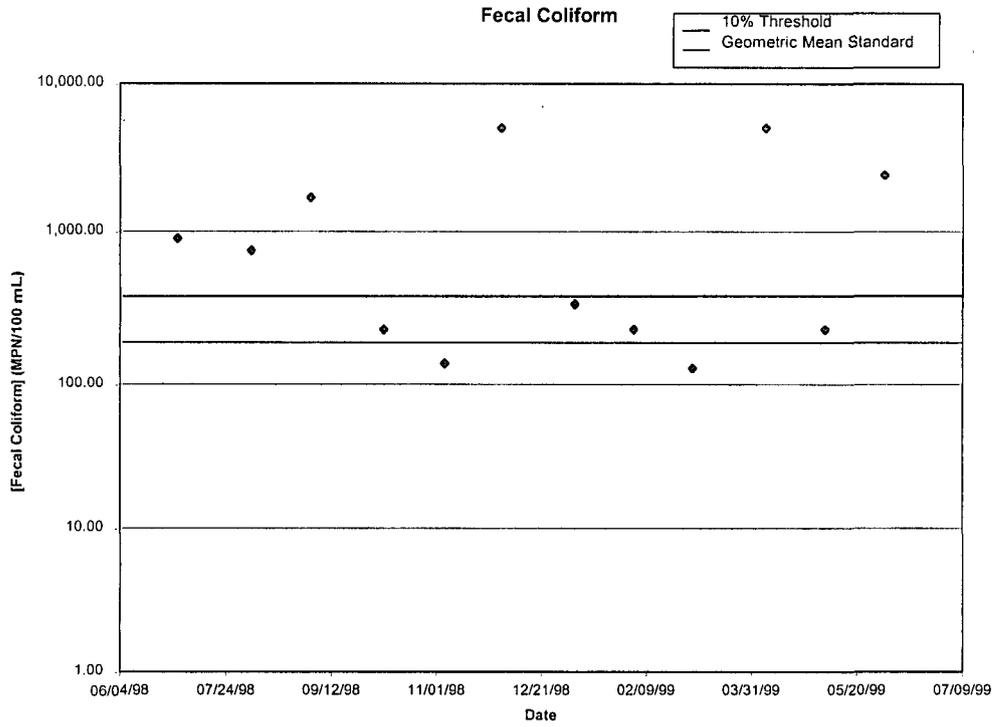
Table 2. Summary of Fecal Coliform Data for Calleguas Creek Reach 4

Dates of Sampling	7/98-6/99
Number of Samples (n)	12
Minimum Data Value	130 mpn/100 mL
Maximum Data Value	5000 mpn/100 mL
Median Data Value	550 mpn/100 mL
Arithmetic Mean Value	1424 mpn/100 mL
Standard Deviation	1809 mpn/100 mL
Number (Percent) above Objective	Geomean of 653 MPN exceeds 200 mpn; 50% exceed 400 mpn.

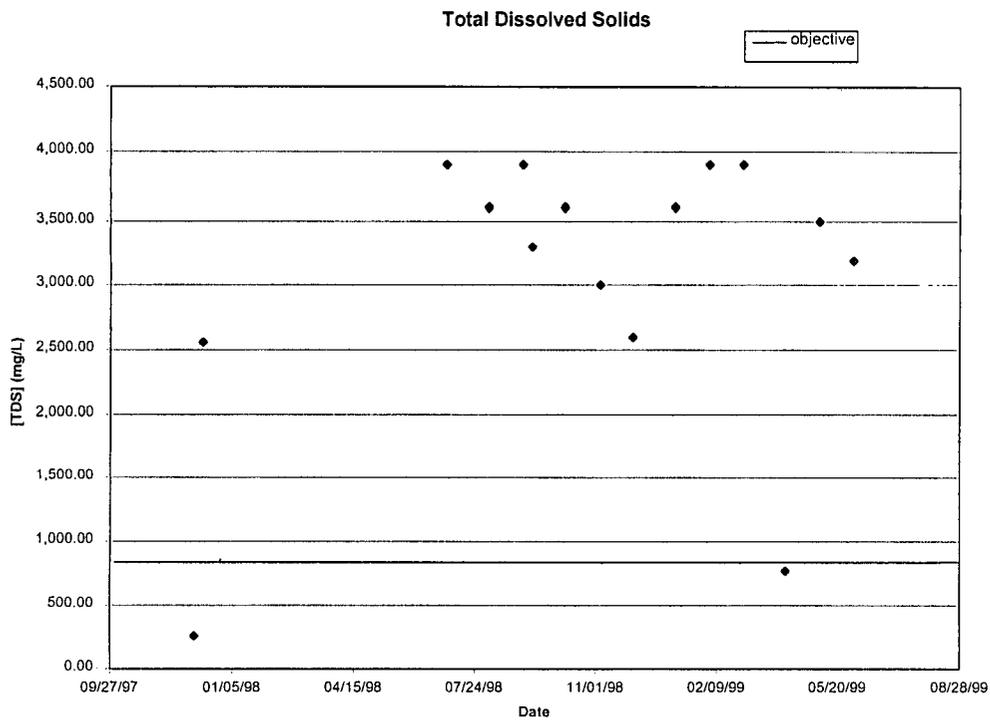
Data Assessment**Table 2. Summary of TDS for Calleguas Creek Reach 4**

Dates of Sampling	12/97-6/99
Number of Samples (n)	15
Minimum Data Value	260 mg/L
Maximum Data Value	3900 mg/L
Median Data Value	3500 mg/L
Arithmetic Mean Value	3039 mg/L
Standard Deviation	1118 mg/L
Number (Percent) above Objective	13 or 87%

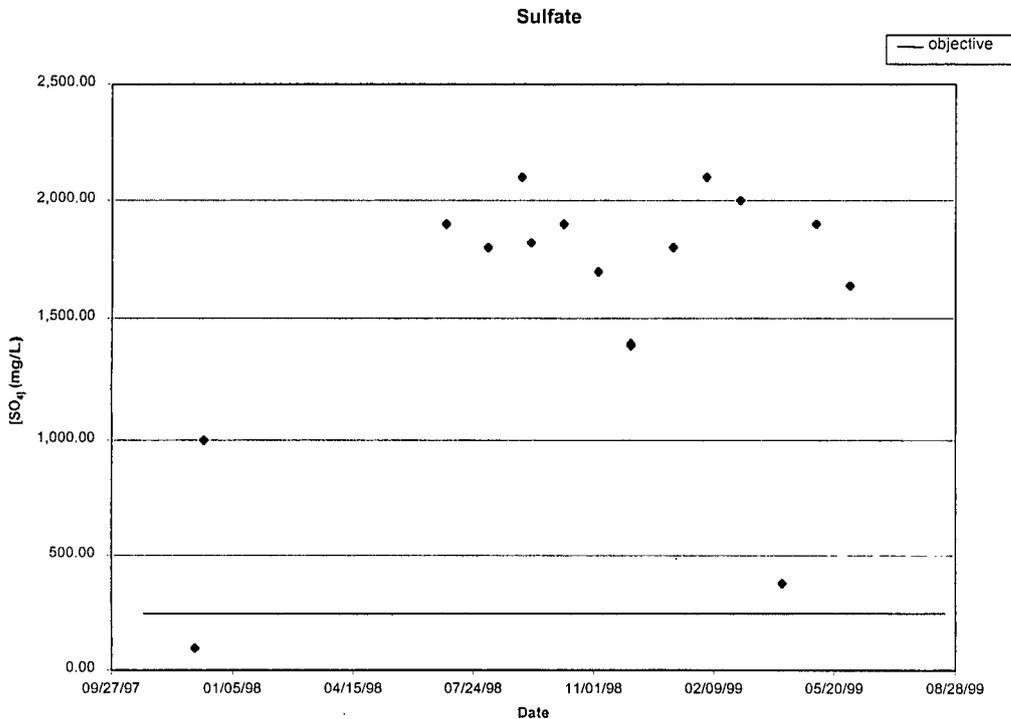
Table 2. Summary of Sulfate for Calleguas Creek Reach 4

Dates of Sampling	12/97-6/99
Number of Samples (n)	15
Minimum Data Value	93 mg/L
Maximum Data Value	2100 mg/L
Median Data Value	1220 mg/L
Arithmetic Mean Value	1204 mg/L
Standard Deviation	608 mg/L
Number (Percent) above Objective	33 or 97%

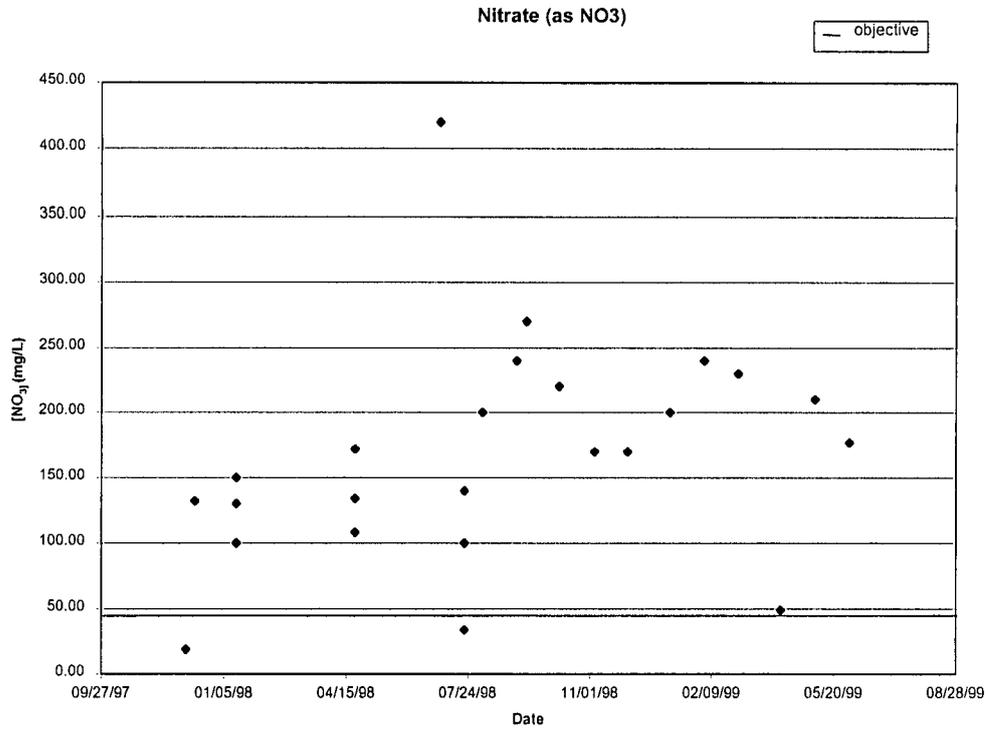
Table 2. Summary of Nitrate as NO₃ for Calleguas Creek Reach 4

Dates of Sampling	12/97-6/99
Number of Samples (n)	43
Minimum Data Value	8 mg/L
Maximum Data Value	420 mg/L
Median Data Value	150 mg/L
Arithmetic Mean Value	144 mg/L
Standard Deviation	77 mg/L
Number (Percent) above Objective	38 (88%)

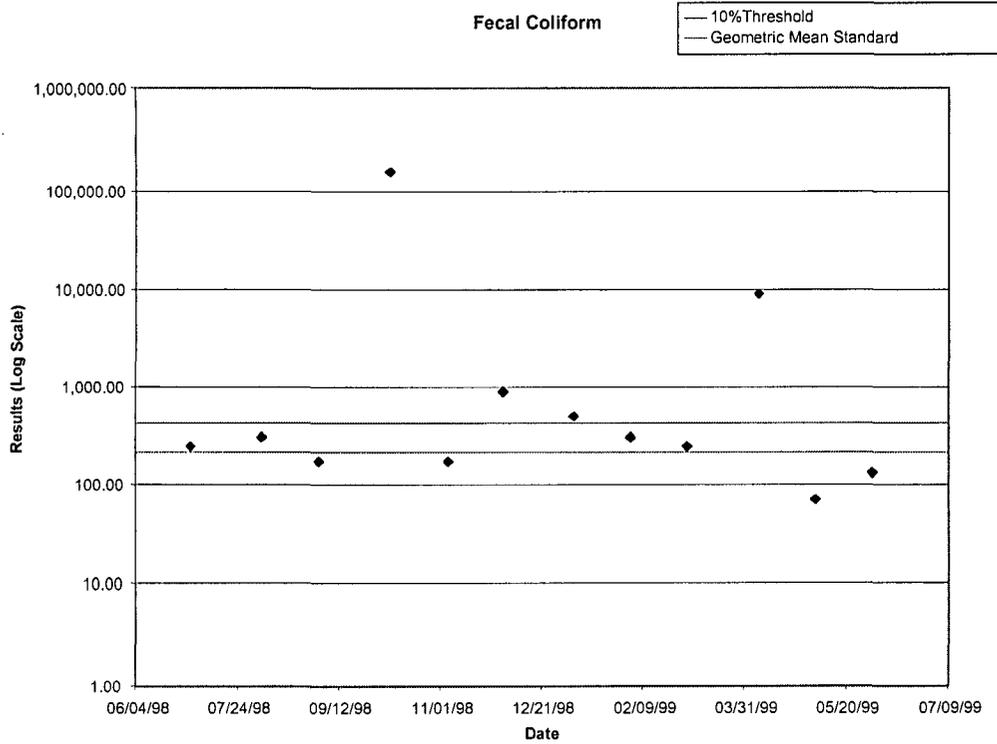
Table 2. Summary of Fecal Coliform for Calleguas Creek Reach 6, Arroyo Las Posas.

Dates of Sampling	7/98-6/99
Number of Samples (n)	12
Minimum Data Value	70 MPN/100mL
Maximum Data Value	16000 MPN/100mL
Median Data Value	270 MPN/100mL
Arithmetic Mean Value	14335 MPN/100mL
Standard Deviation	45941 MPN/100mL
Number (Percent) above Objective	Geomean of 557 exceeds 200; 4 or 33 % exceed 400 standard.

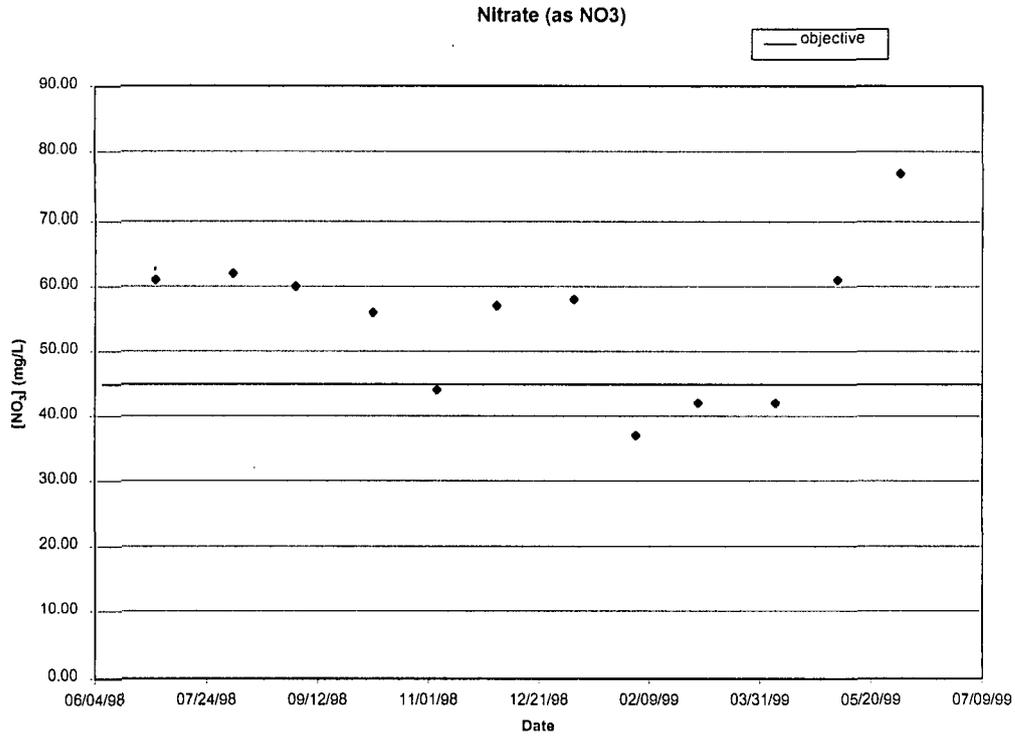
Table 2. Summary of Nitrate as NO₃ for Calleguas Creek Reach 9A - Camrosa Diversion

Dates of Sampling	7/98-6/99
Number of Samples (n)	12
Minimum Data Value	37.0 mg/L
Maximum Data Value	76.6 mg/L
Median Data Value	55.4 mg/L
Arithmetic Mean Value	54.7 mg/L
Standard Deviation	11.3 mg/L
Number (Percent) above Objective	8 or 67%

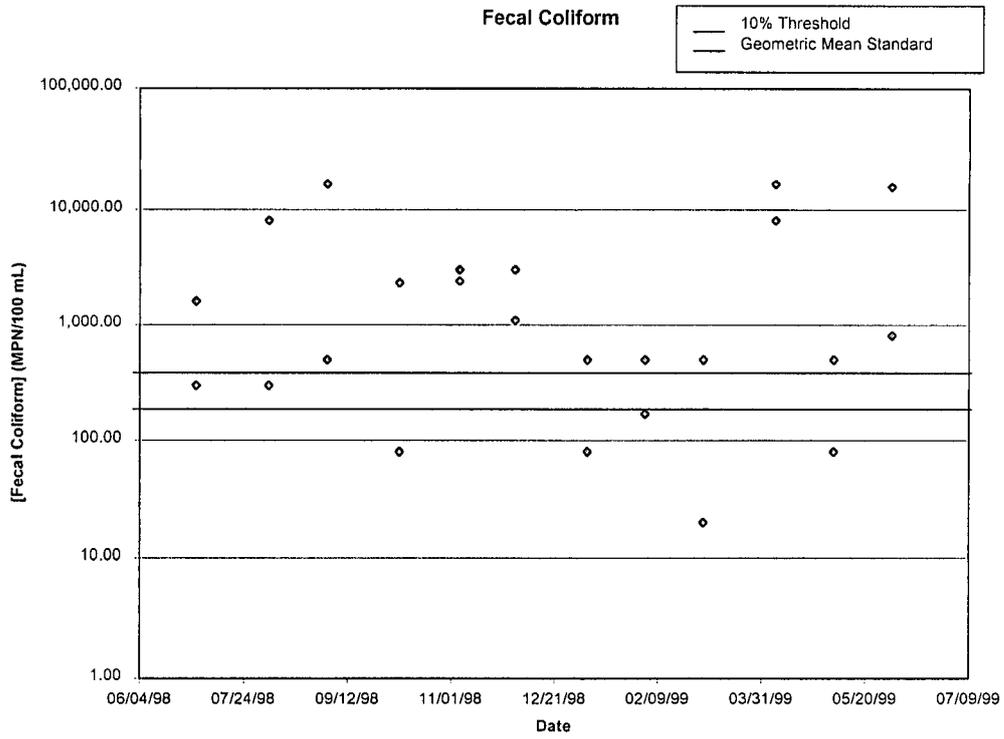
Table 2. Summary of Fecal Coliform for Arroyo Simi, Calleguas Creek Reach 7

Dates of Sampling	7/98-6/99
Number of Samples (n)	24
Minimum Data Value	20 mpn/100mL
Maximum Data Value	17000 mpn/100mL
Median Data Value	300 mpn/100mL
Arithmetic Mean Value	3489 mpn/100mL
Standard Deviation	5536 mpn/100mL
Number (Percent) above Objective	Geomean of 909 exceeds 200 and 17 or 71% of samples exceed 400 standard.

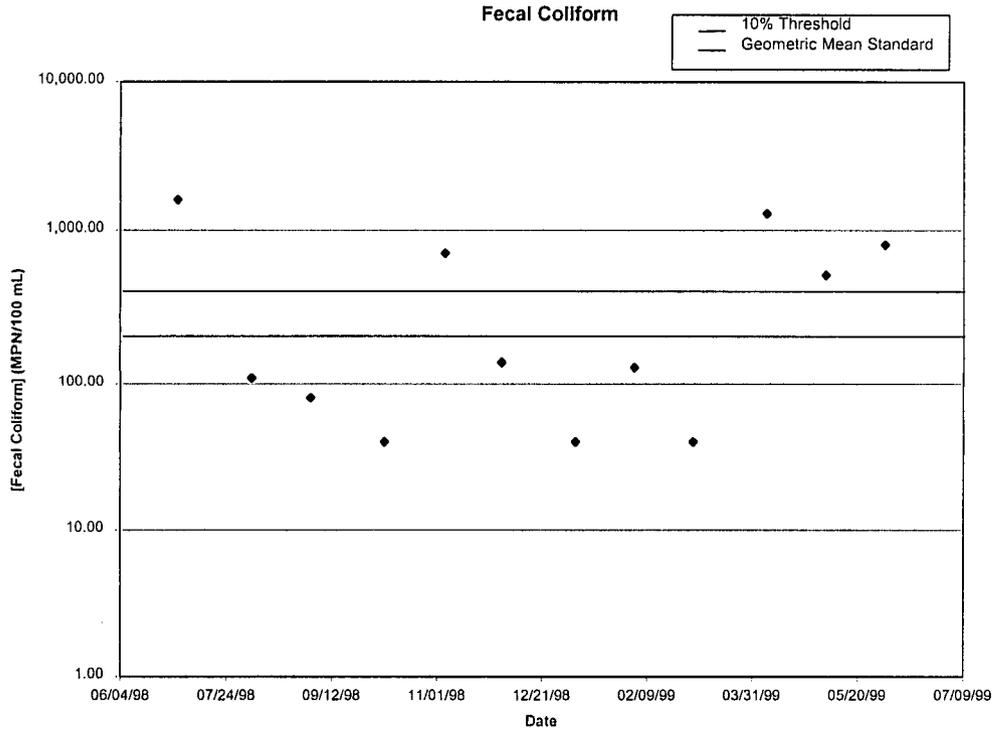
Table 2. Summary of Fecal Coliform for Calleguas Creek Reach 9A Conejo Creek Camrosa Diversion.

Dates of Sampling	7/98-6/99
Number of Samples (n)	12
Minimum Data Value	40 MPN/100mL
Maximum Data Value	1600 MPN/100mL
Median Data Value	135 MPN/100mL
Arithmetic Mean Value	457 MPN/100mL
Standard Deviation	538 MPN/100mL
Number (Percent) above Objective	Geomean of 206 exceeds 200, and 5 (42%) of samples exceed 400.

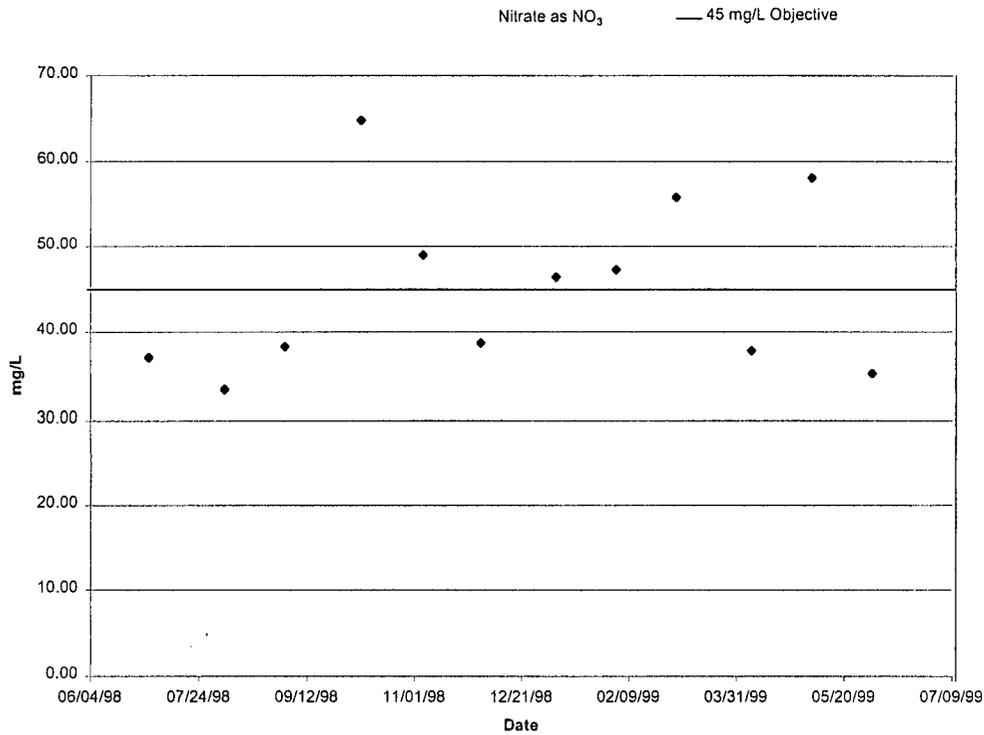
Table 2. Summary of Nitrate as NO₃ for Calleguas Creek Reach 9A Conejo Creek Camrosa Diversion.

Dates of Sampling	7/98-6/99
Number of Samples (n)	12
Minimum Data Value	33.0 mg/L
Maximum Data Value	64.8 mg/L
Median Data Value	42.6 mg/L
Arithmetic Mean Value	45.1 mg/L
Standard Deviation	10.2 mg/L
Number (Percent) above Objective	6 (50%)

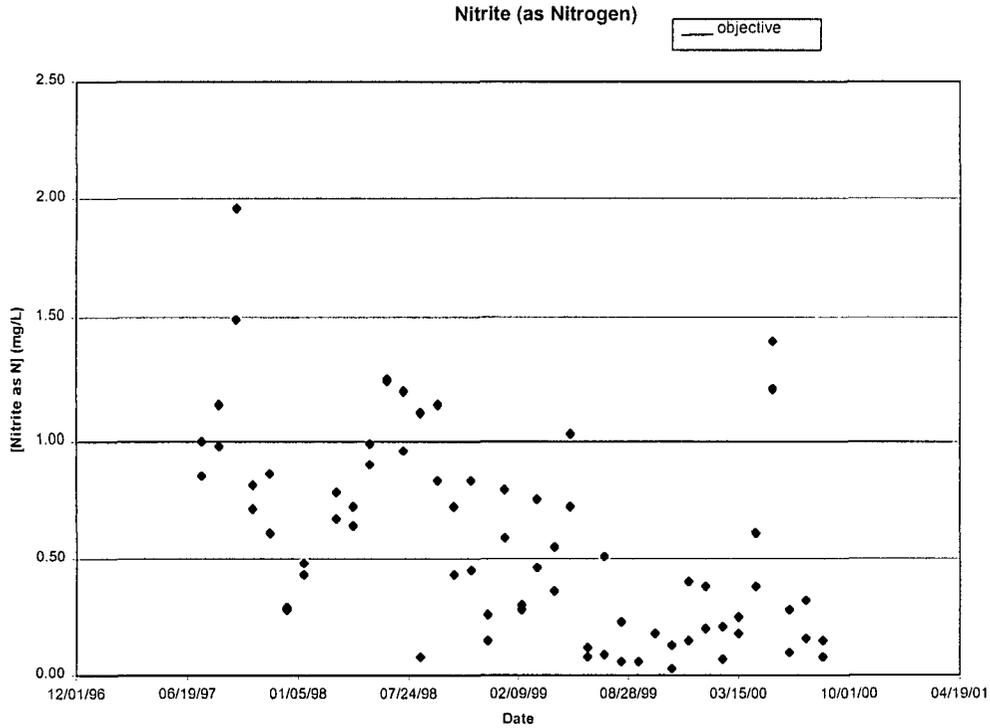
Table 2. Summary of Nitrite as Nitrogen for Calleguas Creek Reach 9A Conejo Creek Camrosa Diversion.

Dates of Sampling	7/97-8/00
Number of Samples (n)	110
Minimum Data Value	0.03 mg/L
Maximum Data Value	1.96 mg/L
Median Data Value	0.51 mg/L
Arithmetic Mean Value	0.58 mg/L
Standard Deviation	0.41 mg/L
Number (Percent) above Objective	18 or 16%

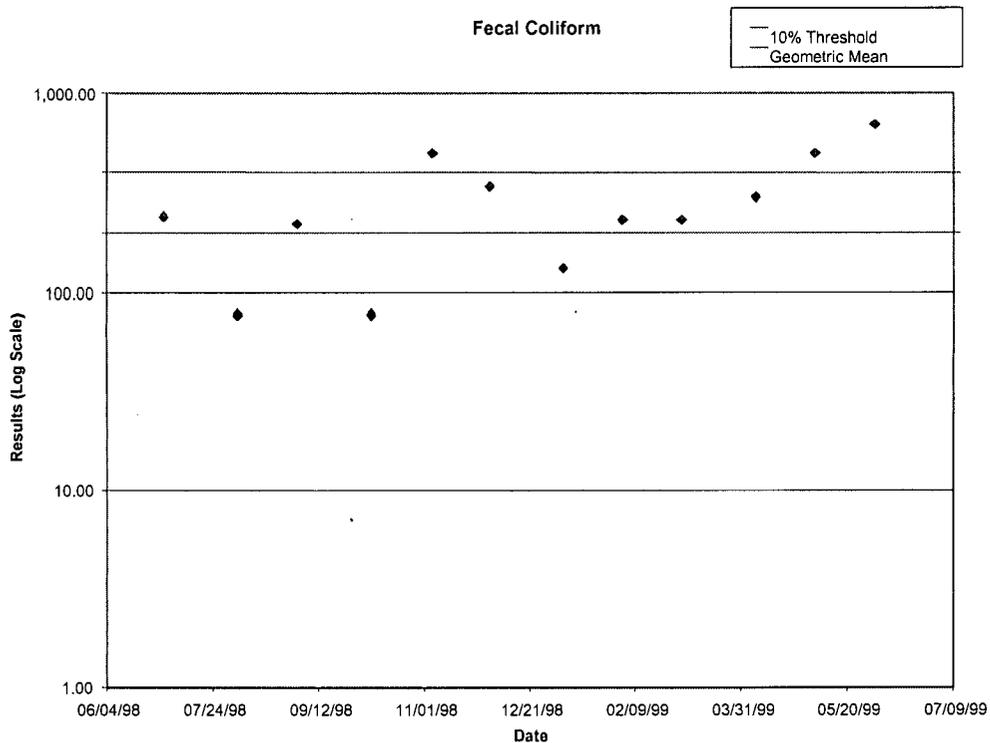
Table 2. Summary of Fecal Coliform for Calleguas Creek Reach 9B, Conejo Creek Main Stem.

Dates of Sampling	7/98-6/99
Number of Samples (n)	12
Minimum Data Value	80 MPN/100mL
Maximum Data Value	700 MPN/100mL
Median Data Value	235 MPN/100mL
Arithmetic Mean Value	296 MPN/100mL
Standard Deviation	188 MPN/100mL
Number (Percent) above Objective	Geomean of 243 exceeds 200; 3 or 25 % exceed 400 standard.

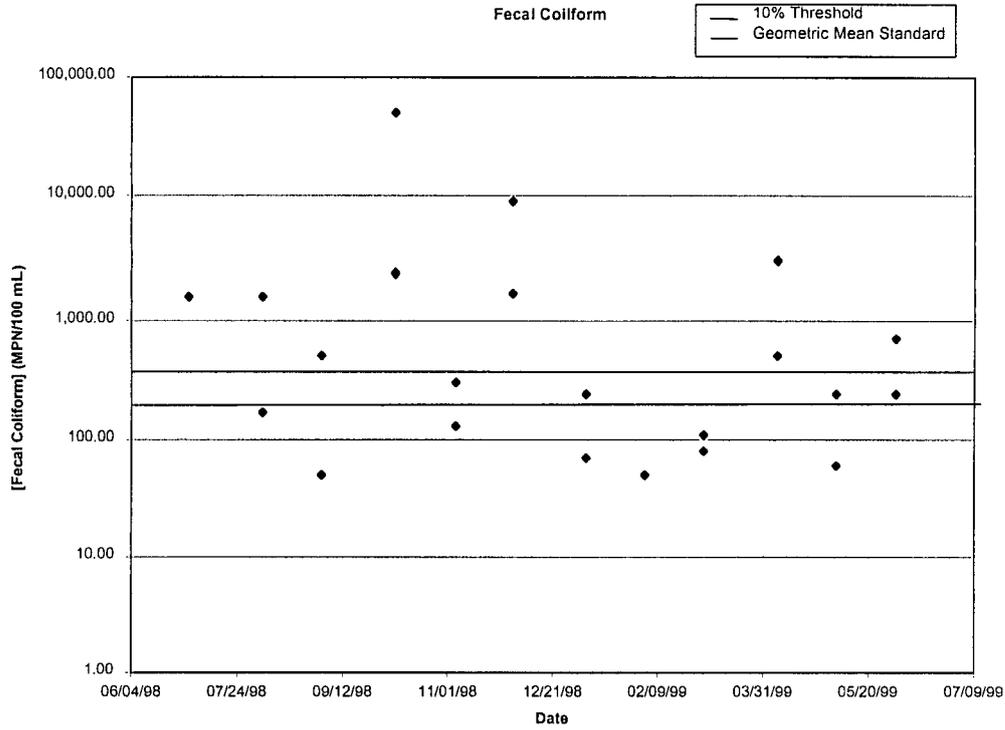
Table 2. Summary of Fecal Coliform Data for Calleguas Creek Reach 10.

Dates of Sampling	7/98-6/99
Number of Samples (n)	24
Minimum Data Value	50 MPN/100 mL
Maximum Data Value	50000 MPN/100 mL
Median Data Value	270 MPN/100 mL
Arithmetic Mean Value	3100 MPN/100 mL
Standard Deviation	10170 MPN/100 mL
Number (Percent) above Objective	Geomean of 431 exceeds 200, and 11 (46%) of the samples exceed 400.

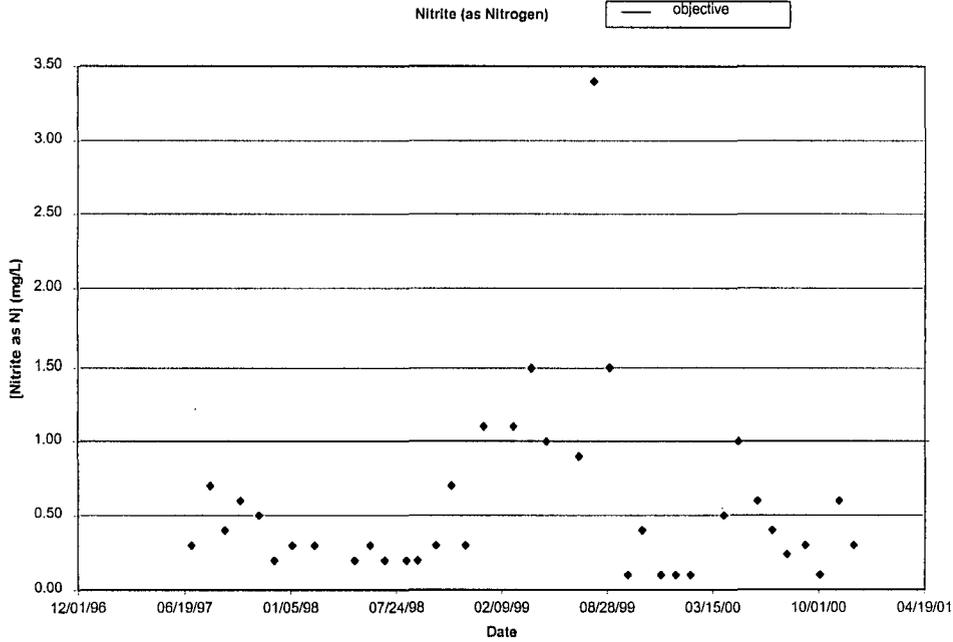
Table 2. Summary of Nitrite as Nitrogen Data for Calleguas Creek Reach 10.

Dates of Sampling	7/97-12/00
Number of Samples (n)	42
Minimum Data Value	<0.10 mg/L
Maximum Data Value	3.4 mg/L
Median Data Value	0.30 mg/L
Arithmetic Mean Value	0.57 mg/L
Standard Deviation	0.61 mg/L
Number (Percent) above Objective	5 (12%) exceed 1.0 mg/L

The parameters used to determine listings require that this reach be listed for nitrite as nitrogen. However, it has been noted that all of the violations occurred before Hill Canyon WWTP completed the addition of nitrification/denitrification to its plant. This will be considered in the next listing cycle.

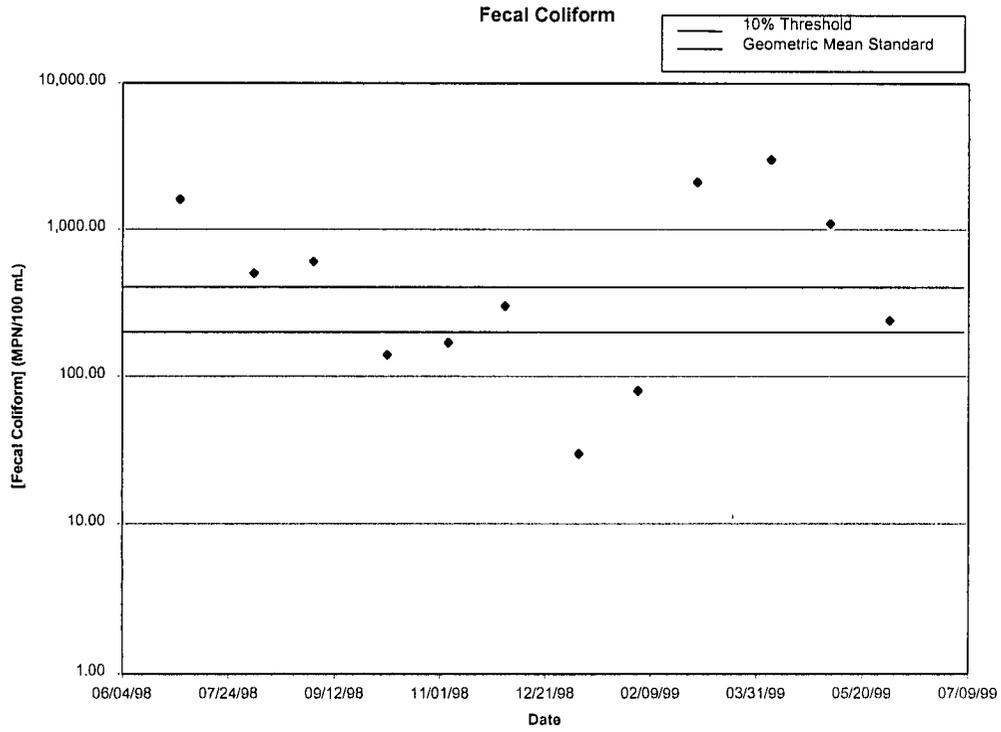
Table 2. Summary of Fecal Coliform Data for Calleguas Creek Reach 11, Arroyo Santa Rosa.

Dates of Sampling	7/98-6/99
Number of Samples (n)	12
Minimum Data Value	30 MPN/100mL
Maximum Data Value	3000 MPN/100mL
Median Data Value	400 MPN/100mL
Arithmetic Mean Value	822 MPN/100mL
Standard Deviation	948 MPN/100mL
Number (Percent) above Objective	Geomean of 393 exceeds 200, and 6 or 50% exceed 400 standard.

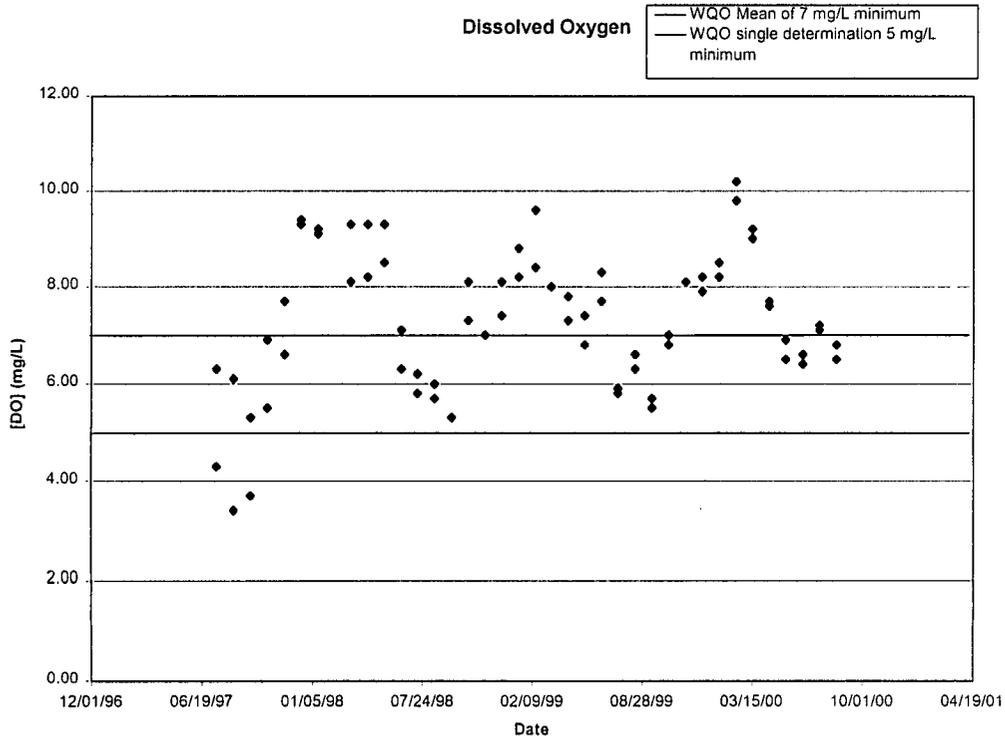
Table 2. Summary of Dissolved Oxygen for Calleguas Creek Reach 9A - Conejo Creek Camrosa Diversion.

Dates of Sampling	7/97-8/00
Number of Samples (n)	111
Minimum Data Value	3.4 mg/L
Maximum Data Value	10.2 mg/L
Median Data Value	7.3 mg/L
Arithmetic Mean Value	7.3 mg/L
Standard Deviation	1.51 mg/L
Number (Percent) above Objective	6 samples or 5.5% have levels less than 5 mg/L.

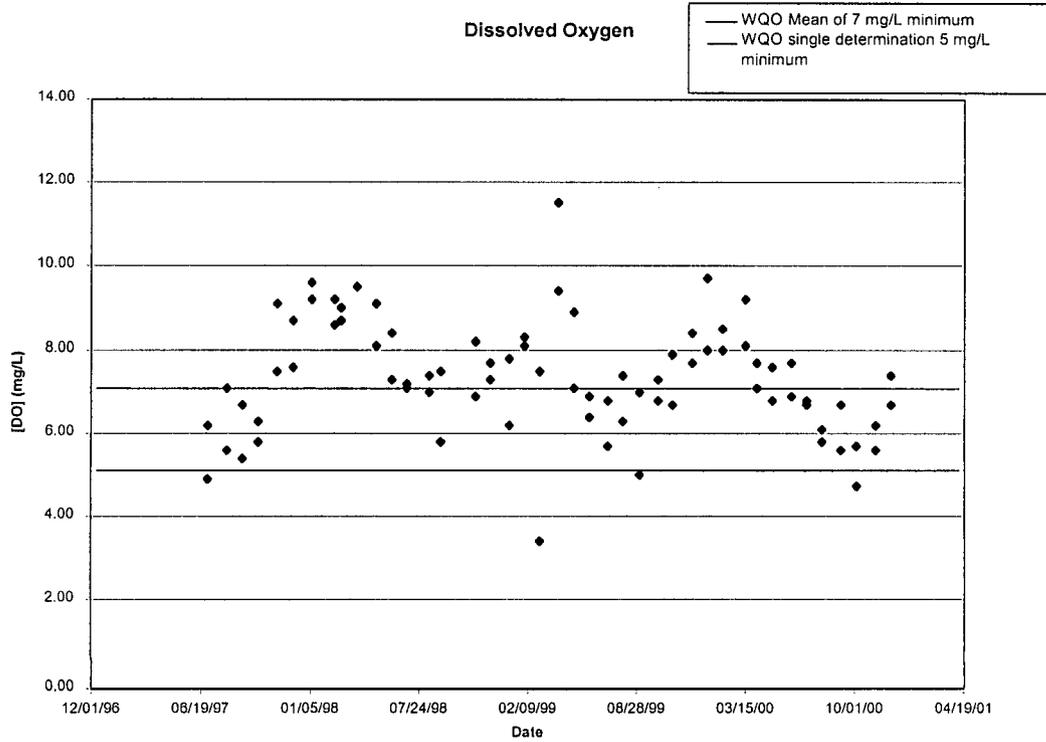
Table 2. Summary of Dissolved Oxygen Data for Calleguas Creek Reach 10.

Dates of Sampling	7/97-12/00
Number of Samples (n)	81
Minimum Data Value	3.4 mg/L
Maximum Data Value	11.5 mg/L
Median Data Value	7.3 mg/L
Arithmetic Mean Value	7.33 mg/L
Standard Deviation	1.35 mg/L
Number (Percent) above Objective	3 samples or 4% were below the criteria of 5 mg/L.

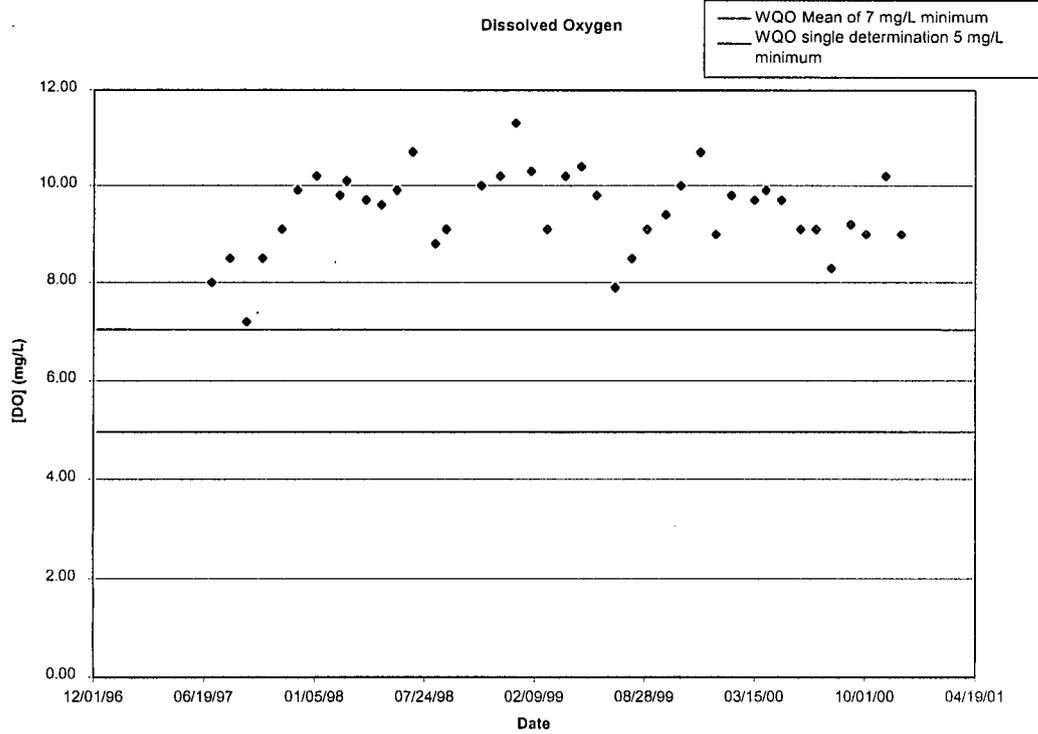
Table 2. Summary of Dissolved Oxygen Data for Calleguas Creek Reach 11, Arroyo Santa Rosa.

Dates of Sampling	7/97-8/00
Number of Samples (n)	41
Minimum Data Value	7.2 mg/L
Maximum Data Value	11.3 mg/L
Median Data Value	9.7 mg/L
Arithmetic Mean Value	9.46 mg/L
Standard Deviation	0.84 mg/L
Number (Percent) above Objective	None, 0%.
